Property Inspection Report

Aaron Egan 450.013239
Northwest Illinois Home Inspectors

410 North Washington Street
Inspection Prepared For: Billie Egan
Agent:

Date of Inspection: 10/18/2024

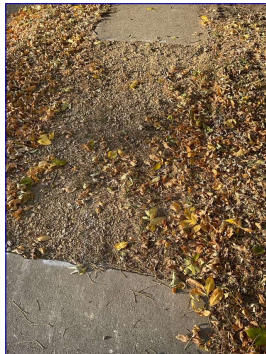
• The public sidewalk is damaged. Potential liability for the homeowner. Recommend repairing or replacing the damaged slabs. Consult a professional contractor as needed.

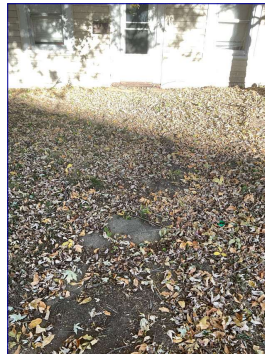
The public sidewalk is damaged. Potential liability for the homeowner. Recommend repairing or replacing the damaged slabs. Consult a professional contractor as needed.

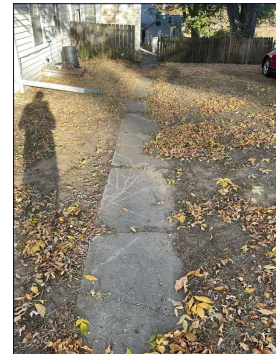
Front walkway appears to be missing

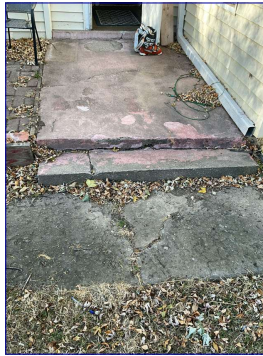
The walkways had some settling but were usable. Recommend monitoring for tripping hazards or sloping towards the home. Consult a licensed contractor for repair or replacement as needed.

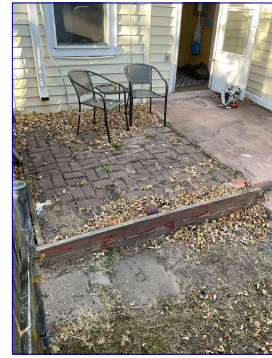
The steps were settled but are in usable condition. Recommend a licensed contractor repair as needed.

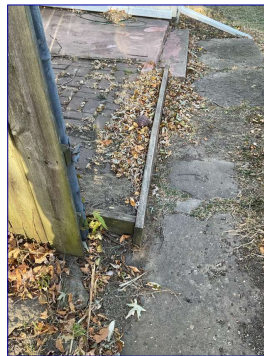
- There is a trip hazard present on the patio. Recommend a licensed contractor repair or replace.

There is a trip hazard present on the patio. Recommend a licensed contractor repair or replace. It appears the wood holding brick patio is decayed and no longer functional. This is a safety hazard that should be addressed.

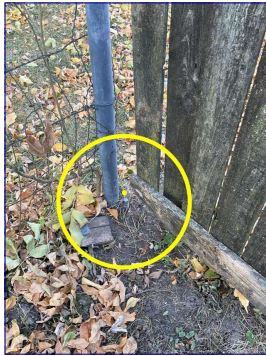
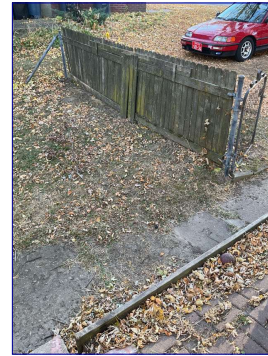
The fence has some damage. Recommend consulting with a professional contractor for regular maintenance repairs.

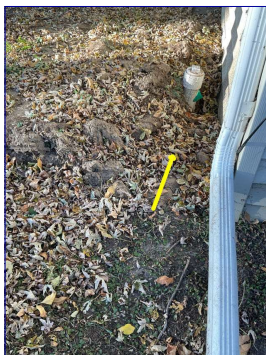
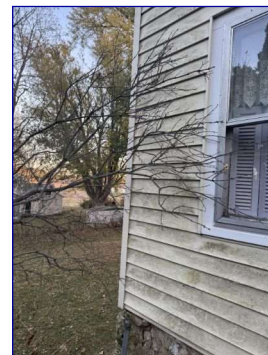
Tree branches rubbing on siding.

There is a negative grading slope, toward the foundation, in one or more locations. Recommend maintaining a positive drainage slope away from the foundation. Consult a professional landscaper for proper drainage and grading as needed.

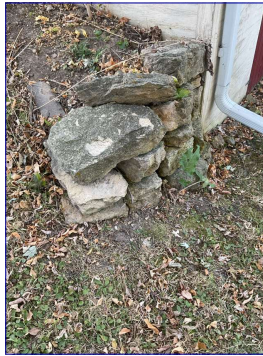
- The retaining wall is in poor condition, and is a safety hazard. Recommend a licensed contractor replace the wall.

Dry stacked stone is not stable. Recommend evaluation by a qualified professional.

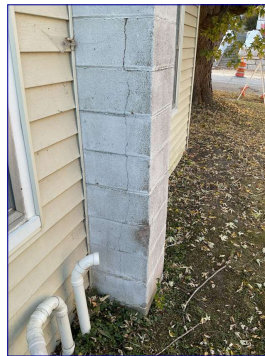
Cracking of concrete block. Monitor and address if necessary.

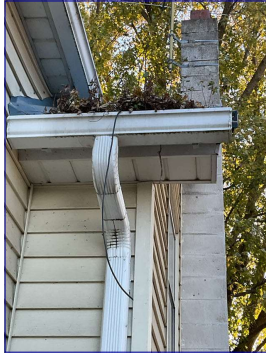
The gutters are dirty. Recommend cleaning the gutters to ensure proper water flow to the downspouts.

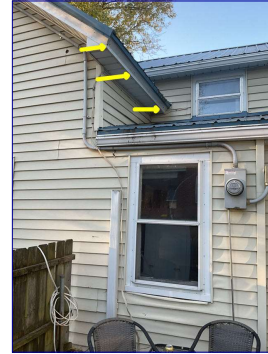
Gutters on only a portion of the house. Recommend a licensed roofer add gutters to properly direct water flow away from the home and the foundation. Facia has holes where gutters were previously installed.

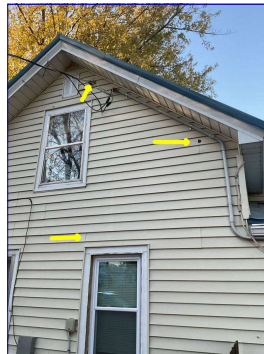
The siding had some damage, recommend a licensed contractor repair/replace damaged sections.

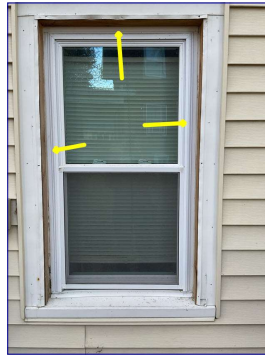
The exterior trim was in need of normal painting maintenance. Recommend a professional painter repair/paint the exterior trim.

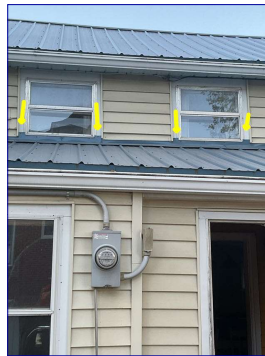
The exterior flashing needed repair in one or more areas. Recommend a licensed contractor repair to prevent additional damage.

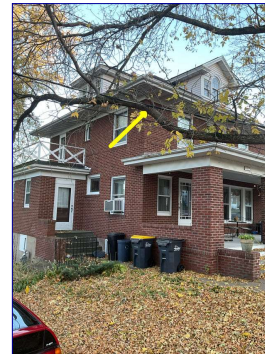
Recommend a licensed electrician/utility company trim the branches away from the roof electric supply lines to the house. This is a safety concern.

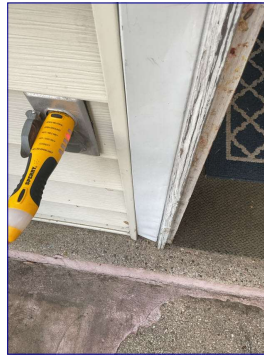
There is open ground on at least one outside receptacle. This is a safety concern. Recommend a licensed electrician repair.

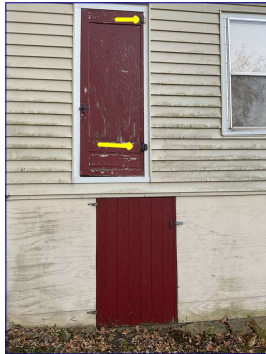
Doors on east end of house upper level with no structure around it. Door is not attached by hinges. Recommend further evaluation

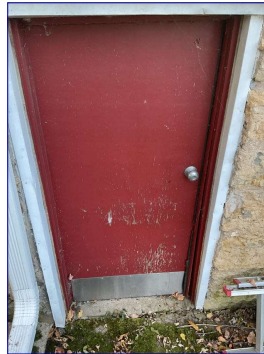
The entry door is weathered. Recommend a professional contractor paint or stain to protect from further damage.

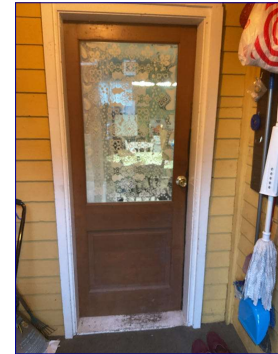
The entry door glass it's not tempered/safety glass. Recommend a professional contractor to replace with tempered/safety glass. This is a safety concern.

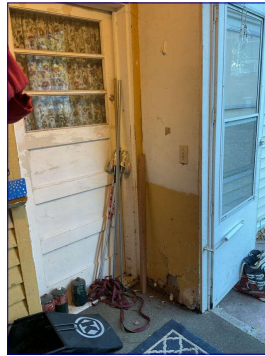
The entry door glass it's not tempered/safety glass. Recommend a professional contractor to replace with tempered/safety glass. This is a safety concern.

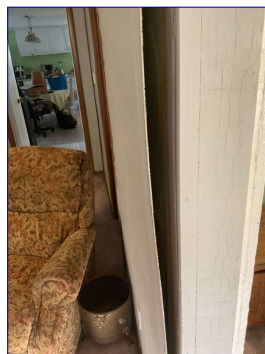
Paneling on south wall coming off, suggest repair or replacement by a qualified professional.

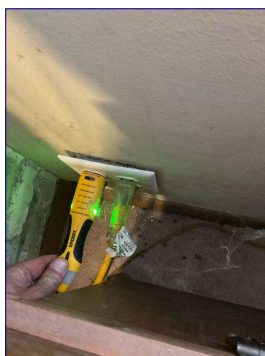
There are loose receptacles present in the living room, which is a potential safety concern. Recommend a licensed electrician repair.

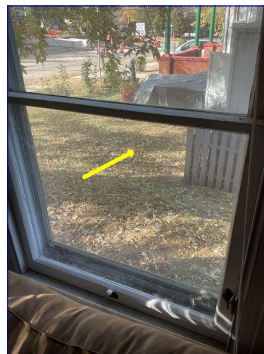
There is cracked glass on at least one window. Recommend a licensed contractor replace the window pane.

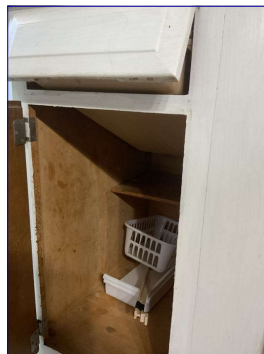
The kitchen cabinet drawers were in need of repair. Recommend repairing or replacing as needed.

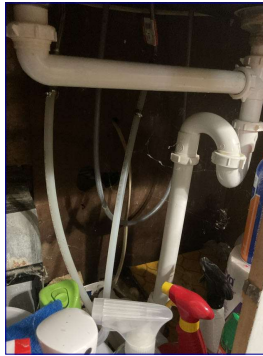
There is an installed S Trap in the kitchen. S Traps can siphon themselves dry which will allow sewer gases to enter the home. To prevent gases from entering the home, fill the trap with water. In addition, we recommend a licensed plumber replace the trap for proper drainage.

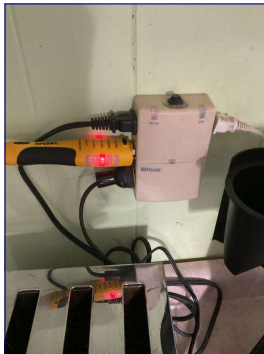
There is at least one receptacle in the kitchen with reverse polarity, which is a safety concern. Recommend a licensed electrician repair.

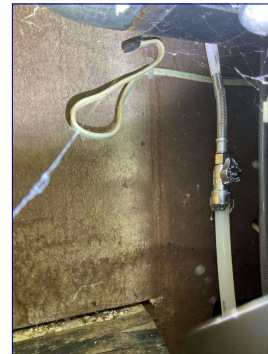
There is an open junction box in a kitchen cabinet, which is a safety concern. Recommend a licensed electrician install a cover plate.

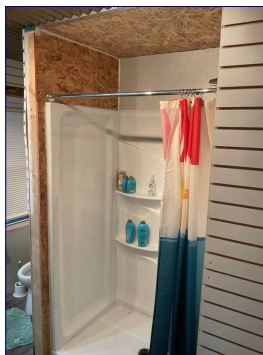
Recommend caulking/grouting in the shower and tub area to help prevent damage from water penetration. Missing paneling on ceiling and rear wall recommend insulation by a qualified contractor.

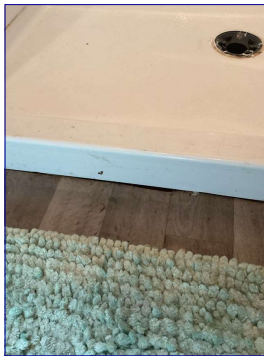
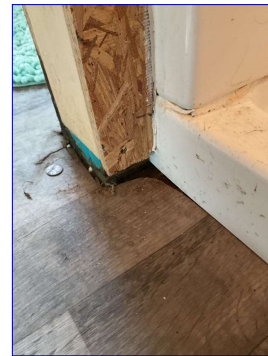
No caulk or flashing to protect subfloor from water damage. Signs of water damage from shower area, replacing shower curtain by homeowner may reduce likelihood of further damage.

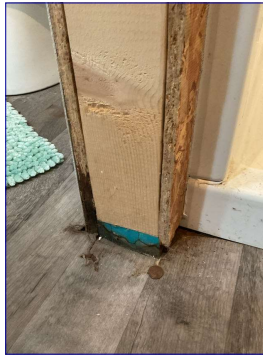
There is staining on the bathroom walls. There was no current moisture at the time of the inspection. Monitor and repair as needed.

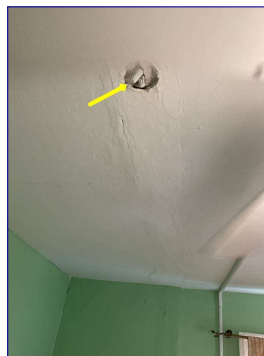
Open exposed energized wires in ceiling. Recommend removal by a qualified electrician.

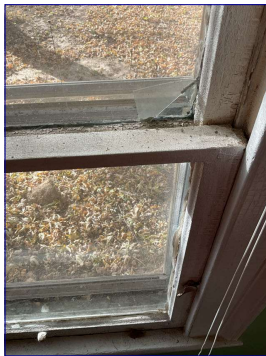
The window has cracked glass. Recommend repair/replacement by a professional contractor as needed.

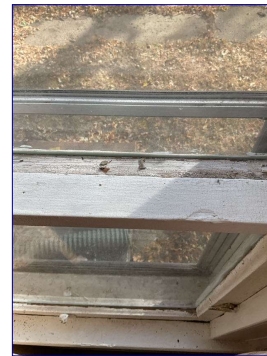
Missing glazing and no counterweight or spring.

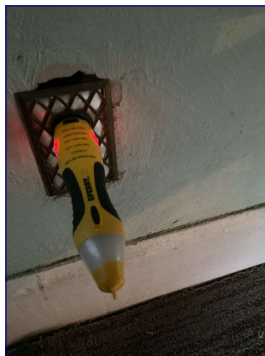
Open ground exists at the receptacles in bedroom 2, which is a safety hazard. Recommend a licensed electrician repair.

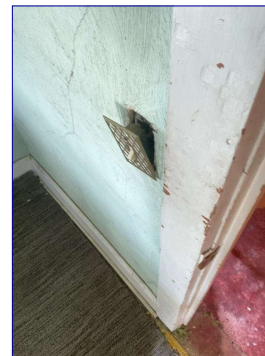
Wall switch not properly installed, large safety hazard. Suggest replacement by a licensed electrician.

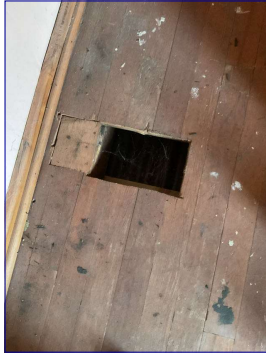
Holes in floor

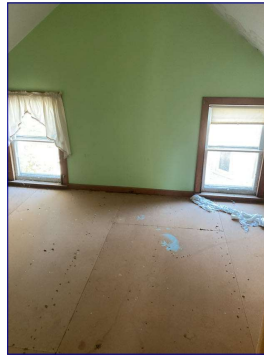
The bedroom windows are located at floor level in bedroom 4, which is a safety concern. Recommend a licensed contractor repair.

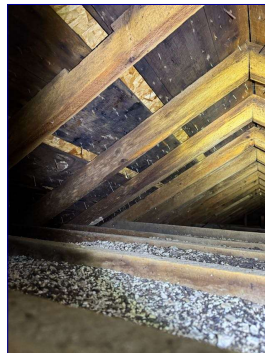
Vermiculite insulation exists in the attic area. Some types of vermiculite have an asbestos-type material, which is a potential safety hazard. Recommend a professional contractor test and remove/remediate the vermiculite as needed.

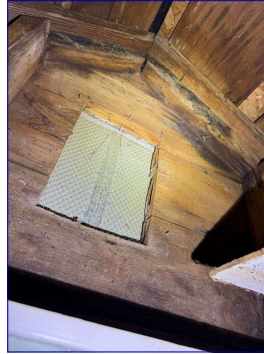
Recommend additional ventilation in the attic space. Calculating the attic ventilation is out of scope for a home inspection; however, there were visible deficiencies. Recommend a licensed contractor add additional ventilation. 2 gable vents were observed from the exterior, one was visible from the attic the hatch.

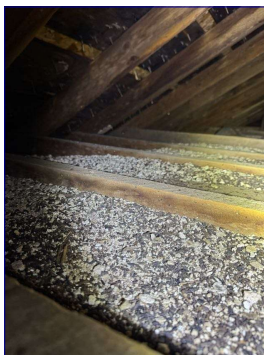
Pests are not part of the home inspection. However, there is evidence of rodent feces in the attic, which is a safety concern. Recommend a professional exterminator be consulted.

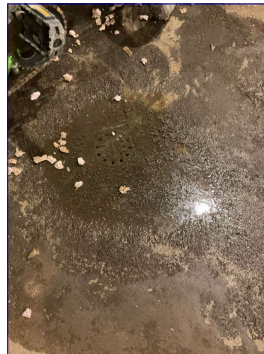
There is water present in the basement, standing water observed at the floor drain- recommend evaluation by a licensed contractor before closing. Repair as needed.

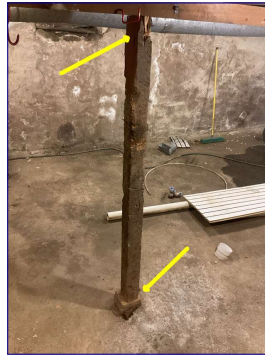
Columns were damaged, as seen in the basement. Recommend a licensed contractor repair or replace.

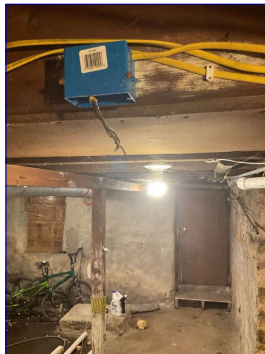
There are open junction boxes in the basement, which is a potential safety concern. Recommend a licensed electrician repair.

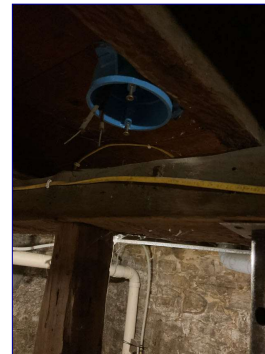
There are open junction boxes in the basement, which is a potential safety concern. Recommend a licensed electrician repair.

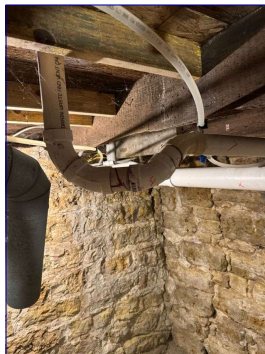
Shower drain has an up hill flow and may cause drainage issues.

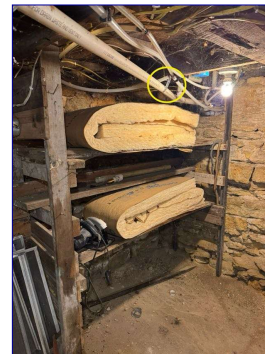
Some of the plastic drain piping, as seen in the basement, is supported with metal hangers. Metal hangers can damage the plastic piping over time. Recommend replacing the metal hangers with proper plastic hangers.

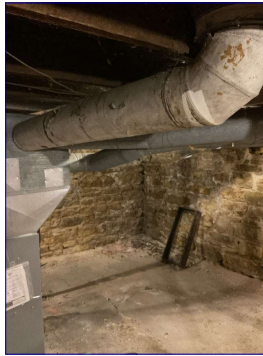
There is an asbestos type material at a number of furnace vent piping. Recommend evaluation and repair by a professional environmental expert, which is a safety concern.

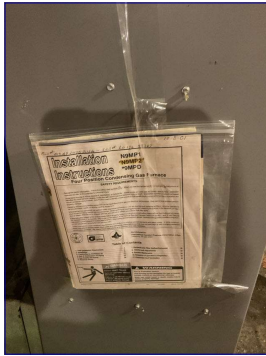
The average life expectancy for a gas-fired forced air system is 15-25 years. Recommend budgeting for replacement.

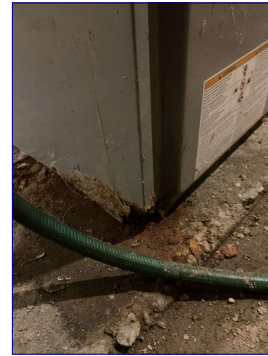
The furnace was in poor condition. Recommend a licensed HVAC contractor evaluation and certification before closing. Repairs or replacements should be made by a qualified licensed contractor.

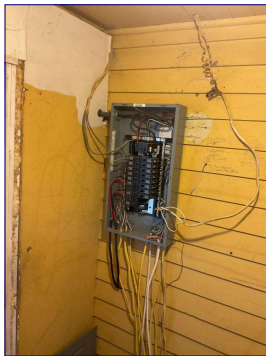
Panel cover not installed as branch circuits are installed from the front of the box not through the box. Recommend correction by a licensed electrician.
