Property Inspection Report

Aaron Egan 450.013239
Northwest Illinois Home Inspectors

410 North Washington Street
Inspection Prepared For: Billie Egan
Agent:

Date of Inspection: 10/18/2024

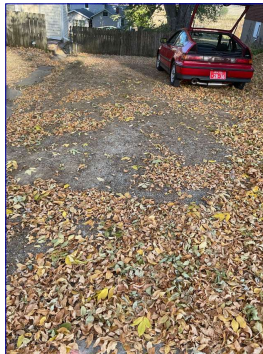
Driveway is integrated in the yard. Some gravel is present but overgrown.

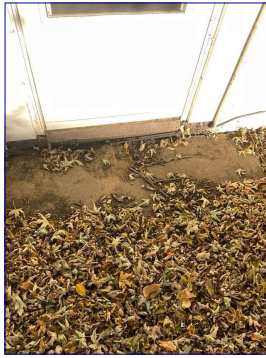
The Steps/Stoop View

- Uneven risers
- Cracked
- Settled

The steps were settled but are in usable condition. Recommend a licensed contractor repair as needed.

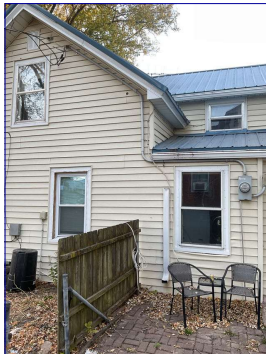
The electrical service drop

- **Recommend a licensed electrician/utility company trim the branches away from the roof electric supply lines to the house. This is a safety concern.**

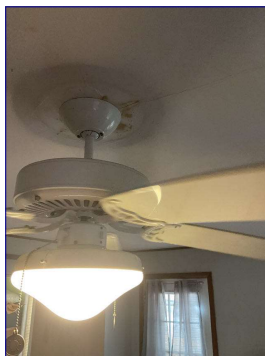
Unsure of ceiling fan mounting, fans should be installed on a proper box rated for a fan.

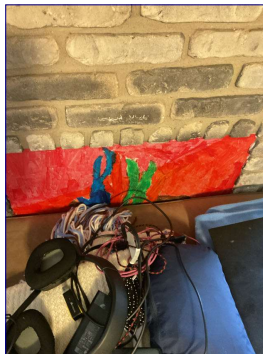
Miscellaneous:
• Fireplace could not be inspected as it is covered by painted plywood.

Nonfunctional fireplace.

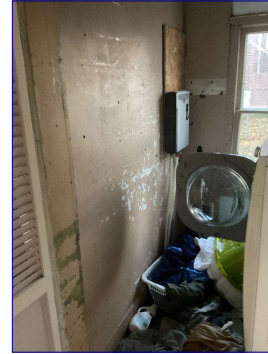
The Laundry Room flaking paint. Possibly contains lead.

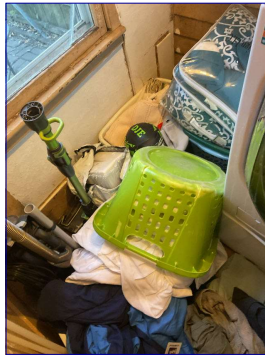
Unable to inspect hookup

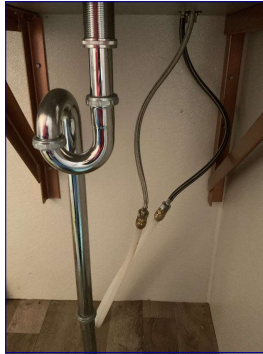
The bathroom plumbing view. S trap present, no shut off valve under sink. S traps can siphon and cause sewer gas to enter the home.

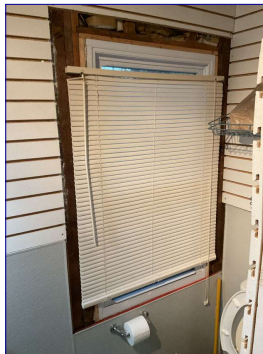
Newer replacement window, missing trim and wall covering. Suggest finishing by a qualified professional.

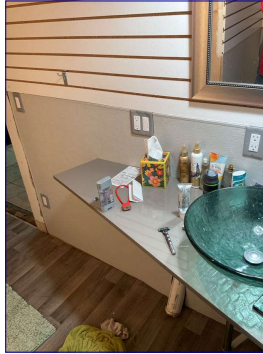
GFCI receptacles are not installed within six feet of water in bathroom 1, which is a safety concern. However, at the time the home was built, installing GFCI receptacles were not part of the standard building requirements. Recommend upgrading the GFCI receptacles to current standards for increased safety.

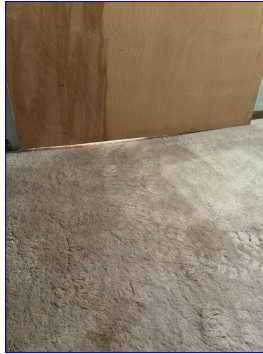
Sliding barn style door will not open fully as it drags on the living room floor, also no stop or hardware. Suggest evaluation and corrections.

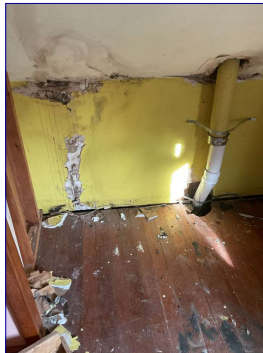
There is staining on the bedroom ceiling. A slightly higher moisture reading found near damage at the time of the inspection. Monitor and repair as needed.

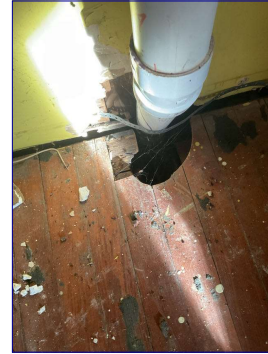
- There are holes located in the floor creating a significant safety hazard.

Holes in floors

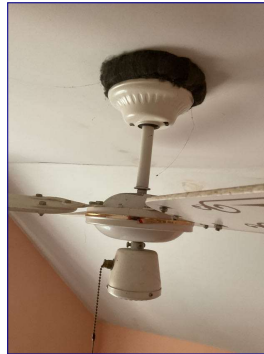
- Ceiling fan is installed but has no light. Ceiling fans are to be mounted on an approved box,

Fan does not appear to be mounted to a proper box. Suggests review by a licensed electrician.

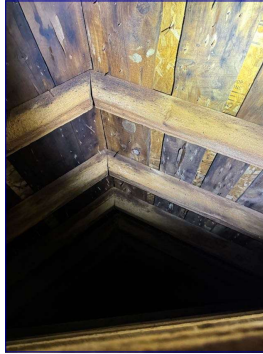
Skip sheathing observed that was overlaid with OSB

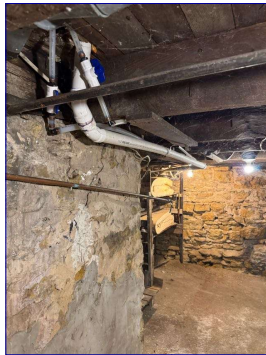
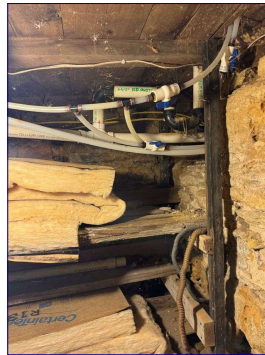
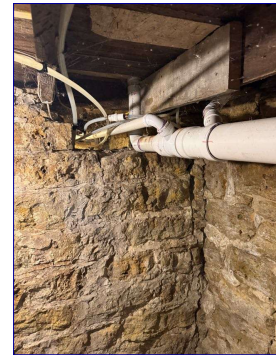
- Sewer lines from the main sewer line to the home are not visible and therefore are not part of the home inspection. This Lateral sewer line is the homeowner's responsibility. Therefore we recommend a sewer line scope/camera inspection by a qualified contractor.
- Some of the plastic drain piping, as seen in the basement, is supported with metal hangers. Metal hangers can damage the plastic piping over time. Recommend replacing the plastic piping with proper plastic hangers.

The visible drain/waste piping
